Smoke and Dye Testing Summary

High Level Sewershed

Test ID	Test Type	Date Inspected	Company / Super.	Blower MH	Ground Condition	Notification Made?	Total Length
S1028-198	Smoke	7/27/2009	ADS/TM	S15A__028MH	Dry	Yes	525.01

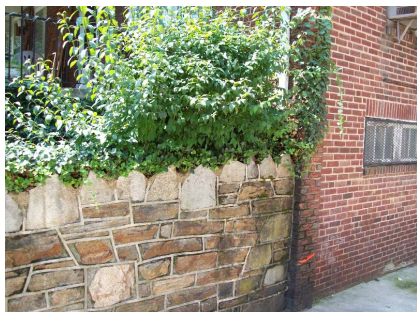
Picture \S1028-198-OB01-P01.jpg

Comments Smoke from service lateral under driveway.
734 Whitmore Ave.

Comments Side of house, 734 Whitmore Ave.

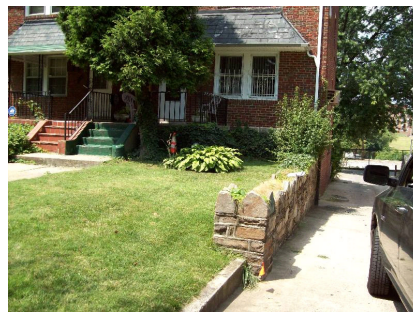
Picture \S1028-198-OB02-P01.jpg

Comments Smoke from service lateral under driveway.
734 Whitmore Ave.

Comments Front of house, 734 Whitmore Ave.
